Think You're Saving With An Unauthorized Repair Shop? Think Again.

A customer brought in a NASH® 2BE1 liquid ring vacuum pump that had locked up. When one of the industry's most reliable pumps fail, you know something is wrong. Our comprehensive disassembly and inspection of the unit revealed what we suspected - the root cause of the pump failure was improper repair work and assembly by an unauthorized repair center.

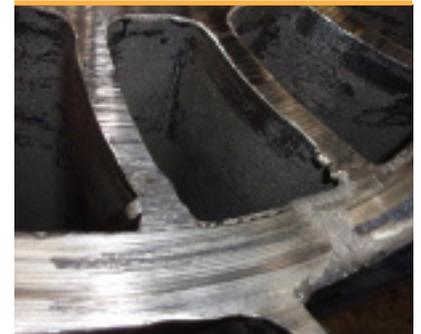
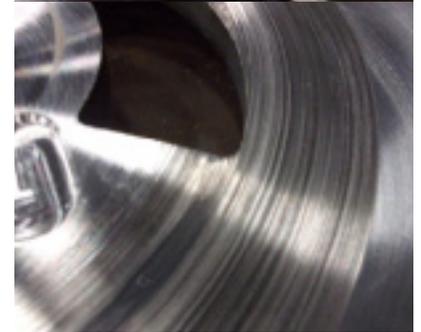
The rotor and portplates of this 2BE1 pump were badly grooved as a result of improper repair and assembly performed by an unauthorized repair shop.

- > The fixed end was modified and didn't properly fit the idle end of the pump. This caused the rotor and shaft assembly to float back and forth, making contact with the portplates.
- > The shaft had been fabricated and was not made to OEM drawing specifications.
- > Both portplates were badly grooved and no longer flat.
- > The rotor faces were badly grooved and the rotor had been cut shorter than standard length. This doubled the pump end travel from the standard OEM dimension.
- > The bearing brackets were modified and couldn't be reused.
- > The fixed end brackets backside had been completely machined off.
- > Ball bearings were installed instead of the standard roller bearings.

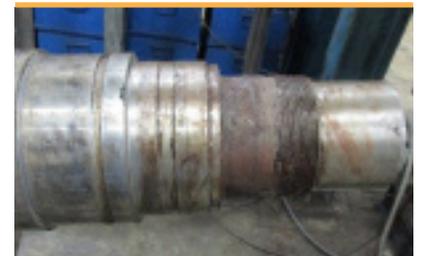
The pump shaft was fabricated by the unauthorized repair shop. It was not made to OEM spec and contributed to further pump damage.
